**GOVERNMENT OF THE
COMMONWEALTH OF DOMINICA**

MINISTRY OF PUBLIC WORKS, ENERGY AND PORTS

Disaster Vulnerability Reduction Project

**Proposed Rehabilitation Of Roads And Drainage Structures
In The Eastern Part Of Dominica**

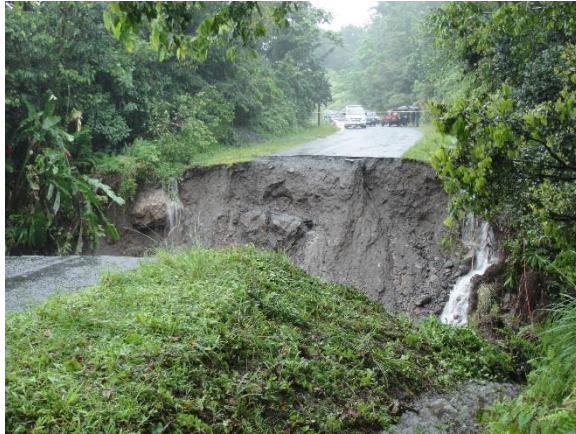
Failure of hydraulic/culvert structure at chainage 1.6km – Following heavy rains from 17 – 19 April 2013, a section of the main road 25m long by 15m deep was washed away.

Figure 4 – Resulting gap in road caused by failure of culvert

Proposal – Replace by a new rectangular reinforced concrete hydraulic box structure and retaining wall.
Cost – EC\$1.2M (US\$0.45M)

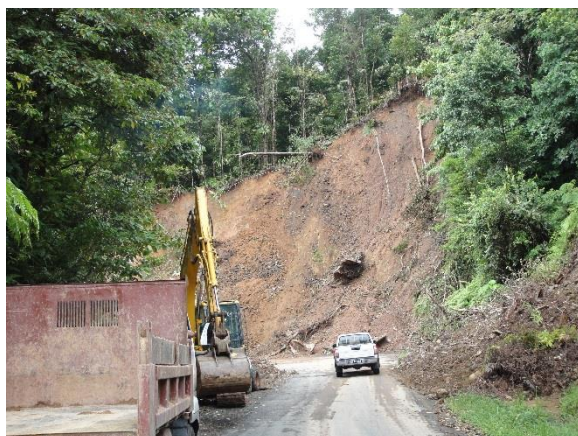
- i) Landslide at chainage 5.2km – Approximate size of landslide is 25m long by 20m high.

Figure 5 – Landslide being cleared

Proposal – Embankment stabilization, drainage, road and safety measures.
 Cost – EC\$0.25M (US\$0.1M)

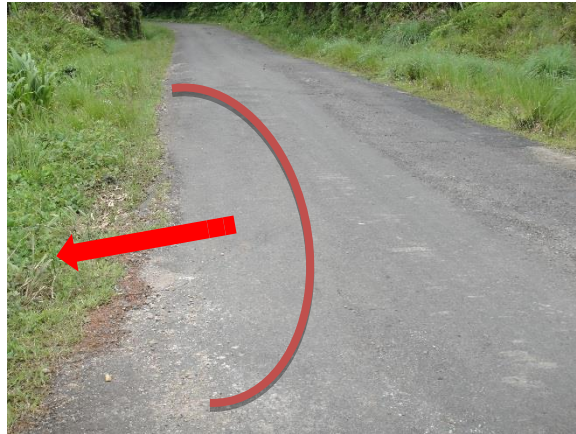
- ii) Subsidence in road pavement as a result of culvert failure – The observed failure can be linked to a failure in the culvert structure

Figure 6 – Subsidence in road showing direction of movement

Proposal – Replace existing culvert structure with new. Overall cost for new structures is provided in Figure 19.

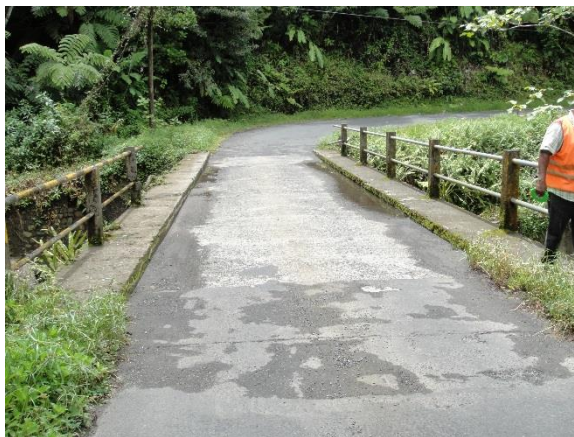
- iii) Bridge at chainage 8.2km – Scour along abutments and missing safety railings. Single lane bridge 18m span by 5m wide and of typical composite construction. Recommended for replacement.

Figure 7 – Missing railings to narrow single lane bridge

Proposal – Existing bridge is of an aged construction and replacement is recommended. Overall cost for new structures is approximately EC\$1.5M (US\$0.55M).

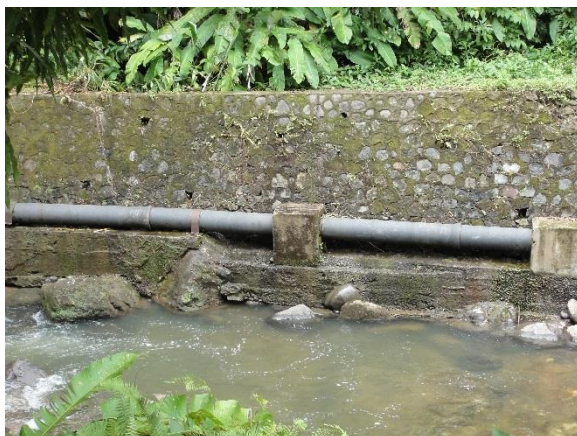
Figure 8 – Scour to bridge abutments due to high flows of river

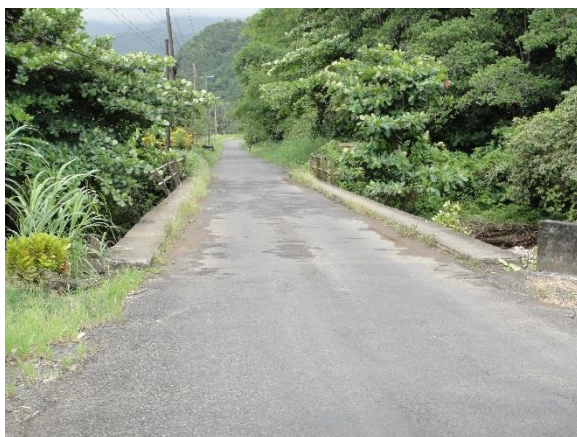
- iv) Bridge at chainage 8.2km at Castle Bruce – The structure as shown in Figures 9 and 10 indicates a compromised structure. In particular, the channel under the 34m span and 5m wide structure has suffered significant siltation. The clearance between the bridge soffit and river is only 1m.

Figure 9 – Damaged safety rails to bridge

Proposal – Existing bridge is of an aged construction and replacement is recommended. In addition, significant upstream/downstream dredging and river training measures are required. Overall cost for new structures is approximately EC\$2.5M (US\$0.92M).

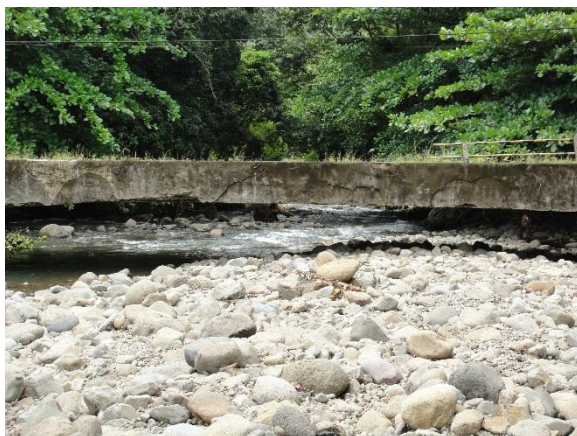
Figure 10 – Heavily silted river channel

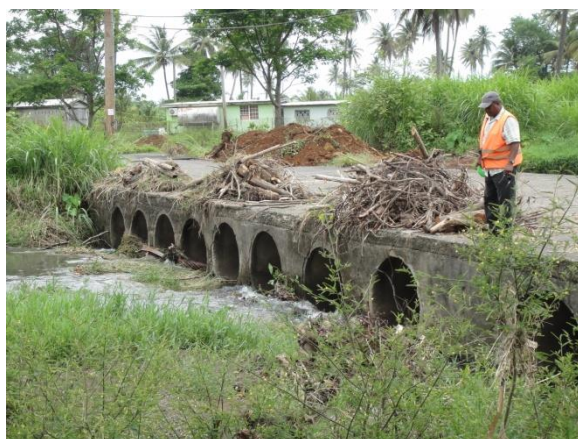
Figure 11 – Causeway at Castle Bruce

- i) Causeway at Castle Bruce – Existing structure at chainage 14.1km with twelve (12) 0.9m diameter culvert pipes are frequently blocked with debris. Consideration to be given to the provision of an adequate structure across the affected location. In addition, the road level may need raising.

Proposal – Given the frequency of overtopping due to obstruction with debris, the construction of a wide span crossing structure/bridge is recommended. In addition, consideration must be given to raising the existing road by at least 1m (for 50m before and after crossing structure) to obtain sufficient clearance between the stream and soffit of the proposed structure. Overall cost for new structures is approximately EC\$1.0M (US\$0.37M).

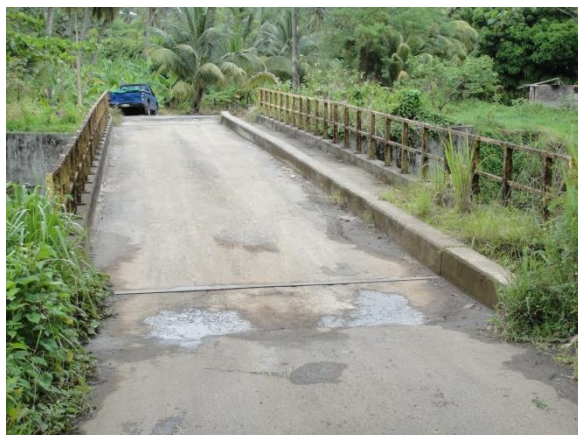
- ii) Bridge at chainage 14.5km – Calixte bridge 24m span by 4.5m wide structures at Castle Bruce in good condition but abutment walls require attention to mitigate the effects of adverse river flows.

Figure 12 – Single lane bridge

Proposal – Abutment walls need to be extended to mitigate the effects of flanking. If not addressed, sustained high river flows may cause undermining and thus, compromise the main structure. The bridge is also narrow and may need widening to accommodate two (2) lane traffic. Overall cost for new structures is approximately EC\$1.0M (US\$0.37M)

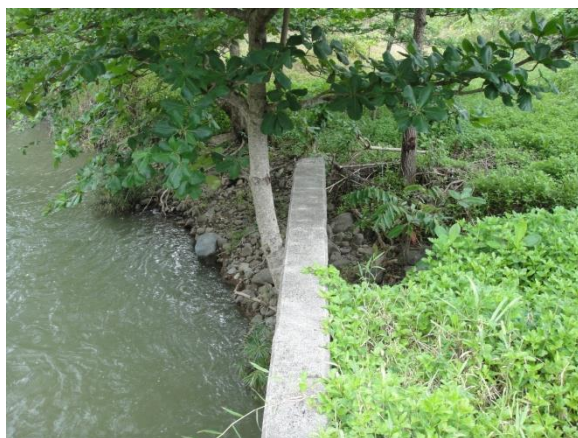
Figure 13 – Both upstream and downstream abutments flanked/scoured

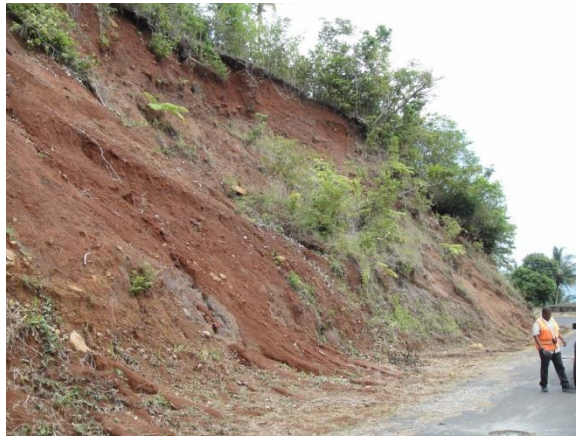
- iii) Landslide location – Situation at chainage 16.5km at Castle Bruce after heavy rains in 2012. Affected section approximately 20m high by at least 500m long. Slope stabilisation required.

Figure 14 – Unstable slopes after landslide at Castle Bruce

Proposal – Embankment stabilization, drainage, road and safety measures.
Cost – EC\$0.25M (US\$0.1M)

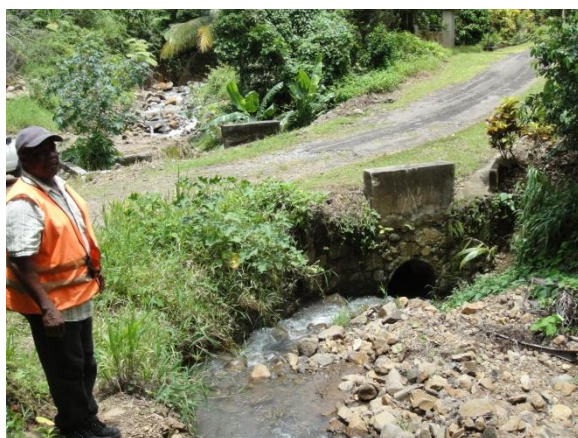
- iv) Hydraulic structure at chainage 19.2km – Two (2) streams flow into existing structures. The capacity of that structure appears inadequate for the levels of discharge and replacement advised.

Figure 15 – Culvert structure with compromised

Proposal – Replace existing culvert structure with new. Overall cost for new structures is provided in Figure 20.

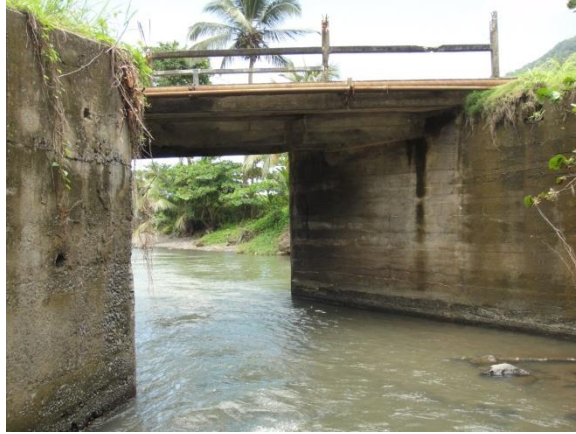
- v) Bridge at chainage 20km – Existing single lane 12.5m by 4m bridge at San Sauveur has severely scoured/undermined. Replacement of structure recommended.

Figure 16 – Small bridge at San Sauveur near shoreline

Proposal – Existing bridge is of an aged construction and replacement is recommended. In addition, the structure is near an aggressive marine environment. Overall cost for new structures is approximately EC\$0.8M (US\$0.3M).

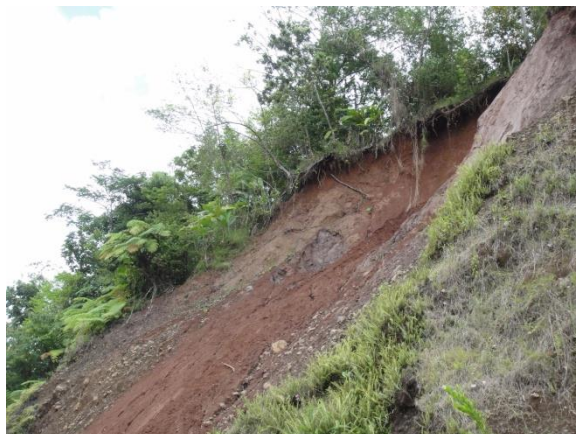
- vi) Unstable slopes at chainage 21km – San Sauveur slopes. Stabilisation measures recommended.

Figure 17 – Unstable slopes at San Sauveur

Proposal – Embankment stabilization, drainage, road and safety measures.
Cost – EC\$1.9M (US\$0.7M)

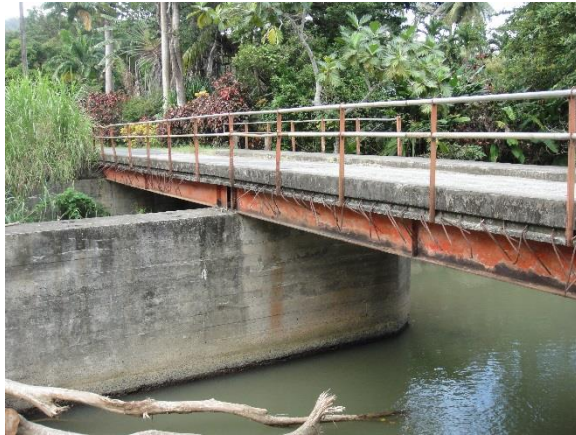
Figure 18 – Hatton Garden Bridge at chainage 20km

Further, at the end of that road link, chainage 20km, is the Hatton Garden Bridge. The steel girders of that composite structure (2 spans of 12m) are severely corroded due to exposure to the marine climate.

Proposal – Rehabilitation and widening of existing bridge is recommended. Overall cost for rehabilitated structure is approximately EC\$2.0M (US\$0.74M).

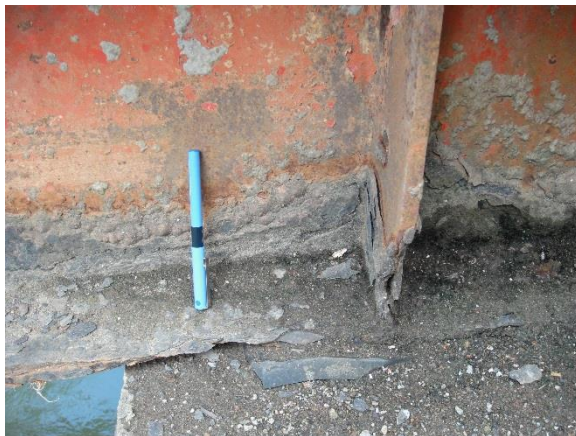
Figure 19 – Corrosion to steel girders of bridge
